**US Army Corps  
of Engineers**

Construction Engineering  
Research Laboratory

USACERL Technical Report M-91/05  
December 1990  
Metallic Surface Treatment Technology for  
Corrosion Resistant Components

# **Development and Testing of an Anti-Scale/Corrosion Resistant Coating for Domestic Hot Water Heat Exchangers**

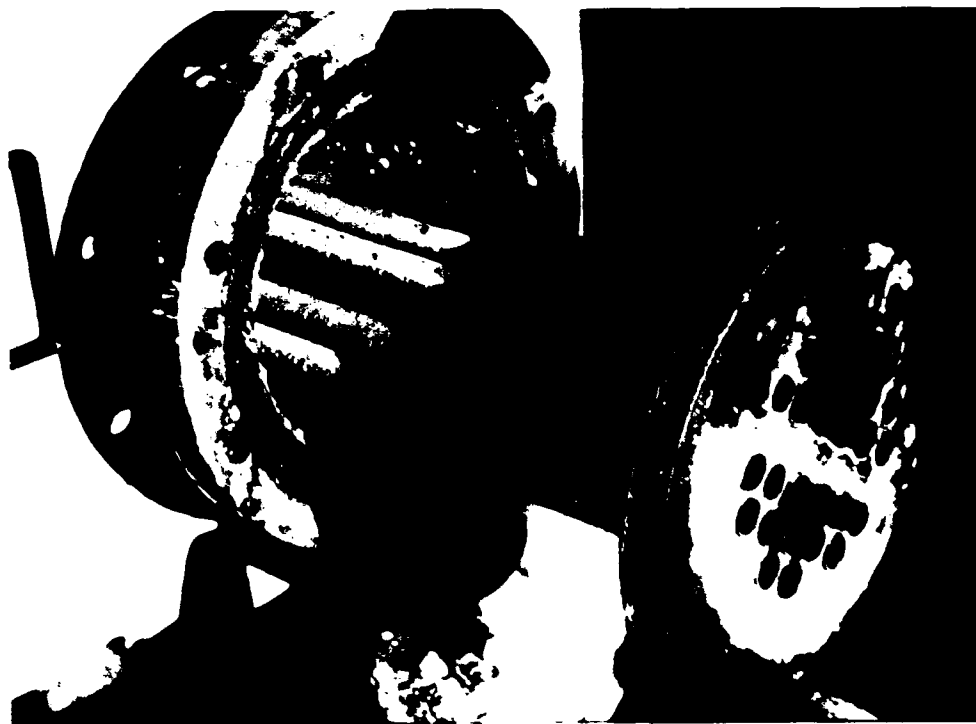
**Figure 8. Removal of heat exchanger tube bundle from Bldg 29006, Fort Hood.**

According to Fort Hood personnel and maintenance records, the tube bundle in this heat exchanger had to be cleaned every 60 to 90 days to remove excessive scale deposits that formed on the waterside surfaces of the tubes. Removing the scale deposits required draining the tank, removing the tube bundle, and soaking it in a large vat of hydrochloric acid until the scale was dissolved. The scale deposits prevented the water from reaching the required temperature of 140 °F for use in the dining hall, especially during peak periods of operation. During the May 1986 site visit, the tank was drained and the tube bundle was removed for observation (Figure 8). The bundle had been in service since 14 January 1986, and examination revealed that significant scale existed on the waterside surfaces of the tubes. The scale measured approximately 0.07 in. thick, representing a significant loss in heat transfer efficiency. Subsequent microchemical analysis showed that the deposit was comprised primarily of calcium carbonate.

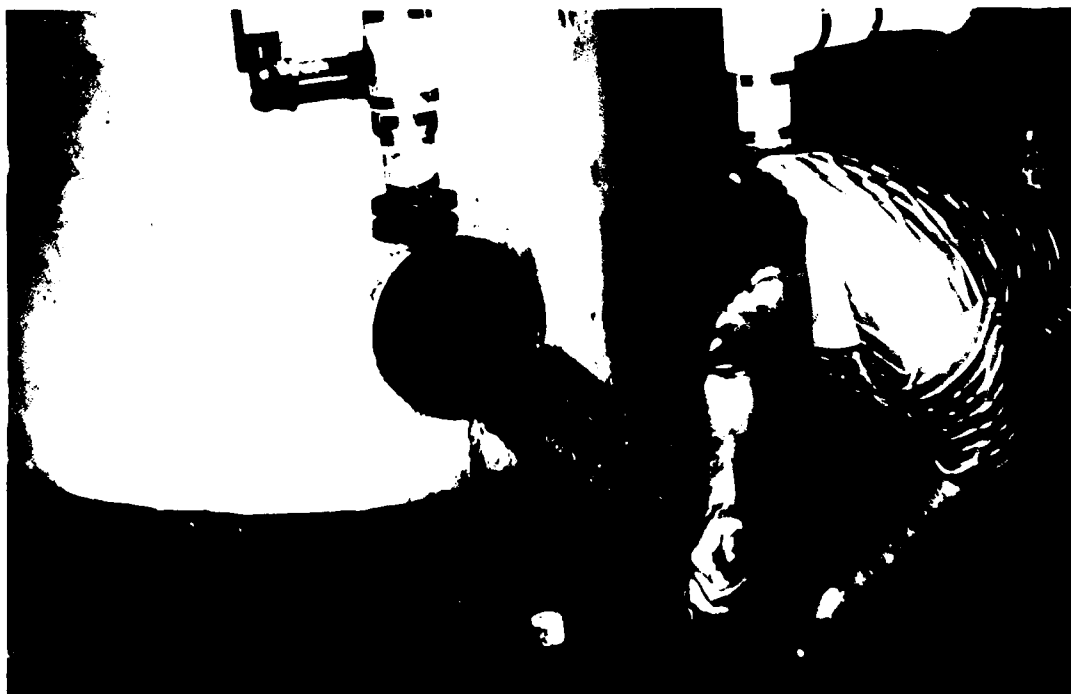
**Figure 9. Removal of tube bundle from Bldg D-3348, Fort Bragg.**

the deposit was comprised of calcium carbonate, hydrated hematite ("red rust"), and products containing phosphorus. The source of the hematite was most likely the corrosion of ferrous-based materials upstream from the heaters. This is understandable since the water at Fort Bragg is relatively corrosive. The deposit immediately adjacent to the bundle surface also contained aluminum, zinc, and copper. It is possible that the sources of the phosphorus and aluminum were chemicals used to treat the river water supply.

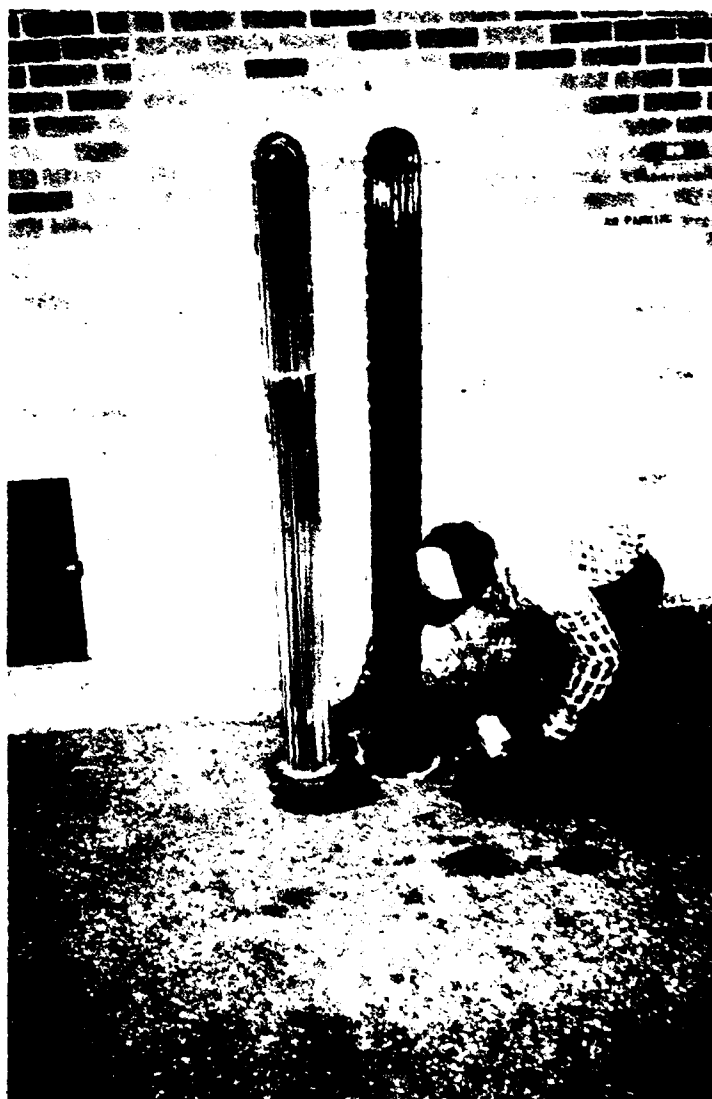
**Figure 17. Scaled vs coated tube bundle, Bldg 29006, Fort Hood.**

On 7 October 1986, an inspection of the coated bundle revealed a few areas of minor, localized, scale formation on the copper tubes. The thickness of the scale, which was mostly on the steam inlet side of the coil, was less than 0.001 in. This represents an 87 percent reduction below the 0.008-in. layer that had formed on the bare copper tube bundle that had been in service for a comparable period of time. Moreover, only a small portion of the surface was affected. Microchemical analysis revealed that the scale was composed primarily of calcium carbonate. The scale was loosely adherent and could be easily removed by gentle wiping. The deposition seemed to have occurred in areas where the circulation of the water in the tank was such that the loosely adherent scale could not be naturally removed by the "washing" action of the incoming water. Also observed was some minor delamination (separation from the pigmented base coat) of the clear topcoating. The coating manufacturer noted that this problem could have occurred because of overbaking during the application process. However, the general appearance of the copper tubes was not significantly different than when it had been installed 82 days earlier. Its performance represents a dramatic improvement over that of the original uncoated tube bundle. The coated bundle was reinstalled immediately following the examination.

On 14 April 1987, a field inspection of both Bldg 29006 and 87017 was conducted. Examination of the coil from 29006 revealed that most of the bundle was covered with a thin layer of calcium carbonate scale less than 0.001 in. thick. The scale was brownish-colored and loosely adherent. Small areas did exist, especially near the steam inlet and between the tubes, where scale was as thick as 0.04 to 0.05 in. As in the October field inspection, some delamination of the clear topcoating was observed. The bundle was temporarily removed for cleaning. Most of the scale could be removed by simply exposing the tube bundle to a high pressure hot water cleaning at the vehicle washing center.

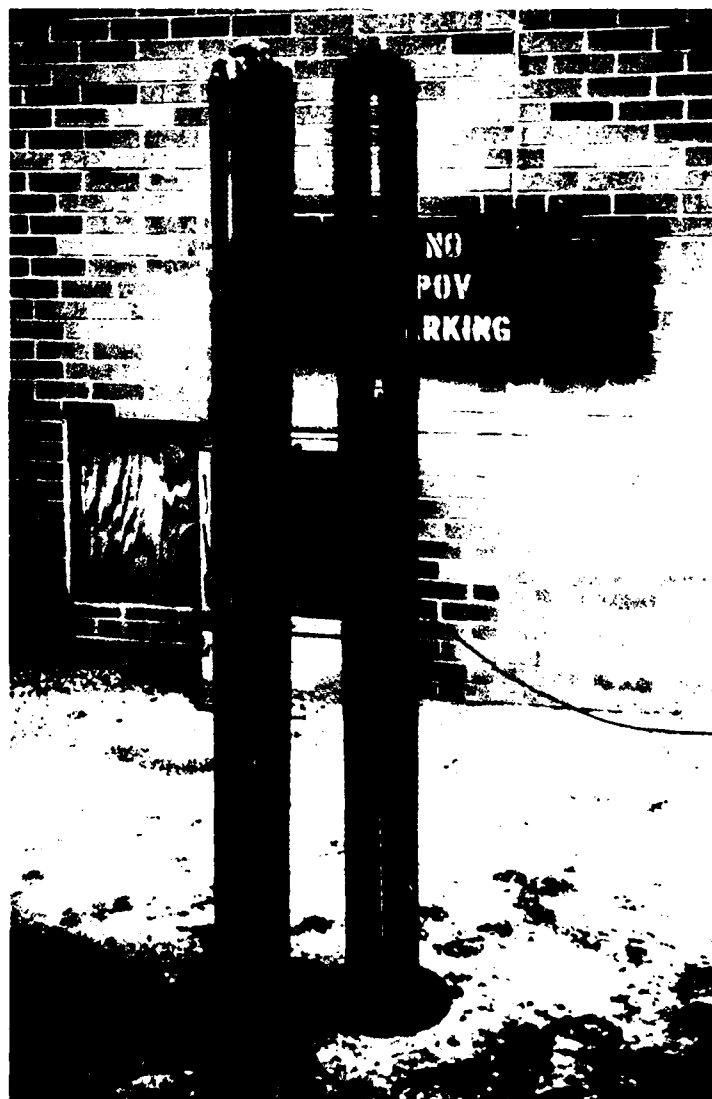
**Figure 18. Scaled vs coated tube bundle, Bldg 87017, Fort Hood.**

A site visit performed on 14-15 October 1986 to examine the heat exchanger in Bldg 87017 revealed that approximately 0.035 to 0.040 in. of calcium carbonate scale had formed on the waterside surfaces of the bundle since its last cleaning in December 1985. A small "booster" water heater had been installed on the hot water outlet because the exchanger itself was unable to maintain the 140 °F water temperature required in the dining hall. During the site visit, the hot water temperature was

The coil in Bldg 87017 was also pulled and inspected. This tube bundle, installed on 8 January 1987, used the coating system with the 50/50 top coat described above. Scale accumulation was more severe, with thicknesses reaching 0.08 in. near the steam inlet. However, the scale was loosely adherent and powdery, and could be removed with the pressure washer used at Bldg 29006. The coated bundle was reinstalled after cleaning.
